# Vardemuseerne *Case Study*

KI FUTURES  
GETTING CLIMATE CONTROL  
UNDER CONTROL PROGRAM  
2023-2024

Vardemuseerne

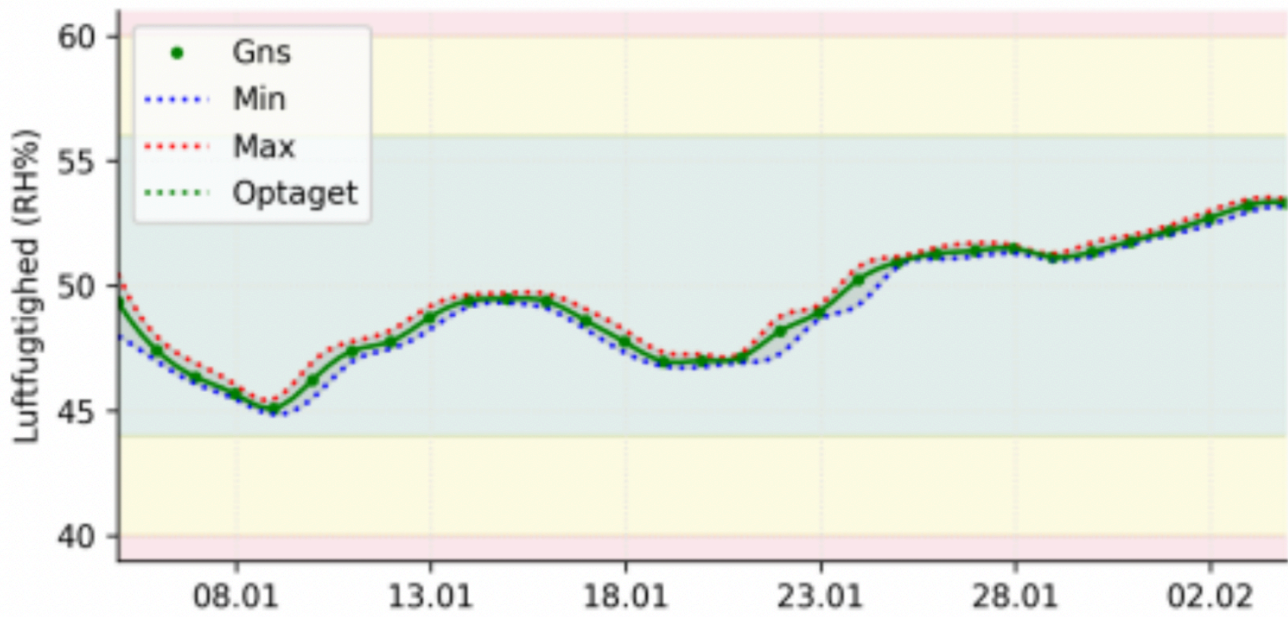
# Charts for Styrofoam boxes

Result: The climate data inside the boxes is more stable, with softer curves. Both the Styrofoam and cardboard boxes show a stable microclimate, though slightly more so in the Styrofoam boxes. However, the difference is minimal.

- For many years, it has been standard at Vardemuseerne to store smaller objects in Styrofoam or cardboard boxes. This practice has several advantages. It optimizes space in the storage area, as the boxes can be stacked, and it provides extra protection against mold, as any outbreak would be contained within a single box. This allows the museum staff to detect it before it spreads to the rest of the collection. Previously, the museum had not examined the potential climate-related advantages or disadvantages of storing objects in Styrofoam and cardboard boxes. We had no data showing how humidity in the boxes behaved compared to the rest of the room. Therefore, monitoring the microclimate in the two types of boxes has been part of Vardemuseerne's contribution to this project. Monitoring was conducted by placing a data logger in both a Styrofoam and a cardboard box. The boxes were placed side-by-side on a shelf at a height of 1.20 meters. Another logger was placed next to the boxes to monitor the climate in the surrounding area. The loggers have been active for a little over a year.
